INSTALLATION INSTRUCTIONS

STEP BOARD MOUNT KIT

2019 Chevy Silverado/GMC Sierra 1500 Crew Cab & Double Cab (Excl. 2019 Silverado/Sierra LD/1500 Limited)

27-2255

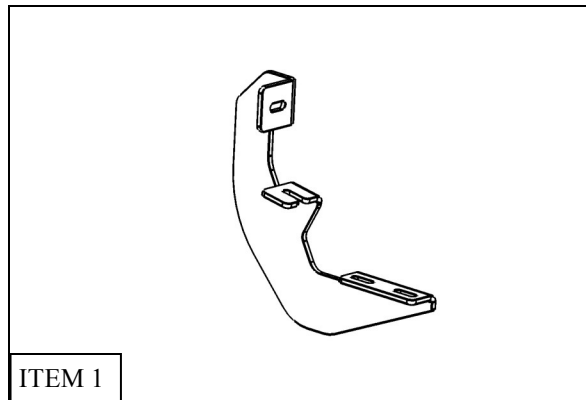
CONTENT			
ITEM	QUANTITY	DESCRIPTION	TOOLS NEEDED
1	6	MOUNTING BRACKET	13MM SOCKET
2	12	M8 HEX HEAD BOLT	RATCHET
3	24	M8 FLAT WASHER	TORQUE WRENCH
4	12	M8 SPLIT LOCK WASHER	
5	12	M8 SQUARE HEAD BOLT	
6	12	M8 NYLOCK NUT

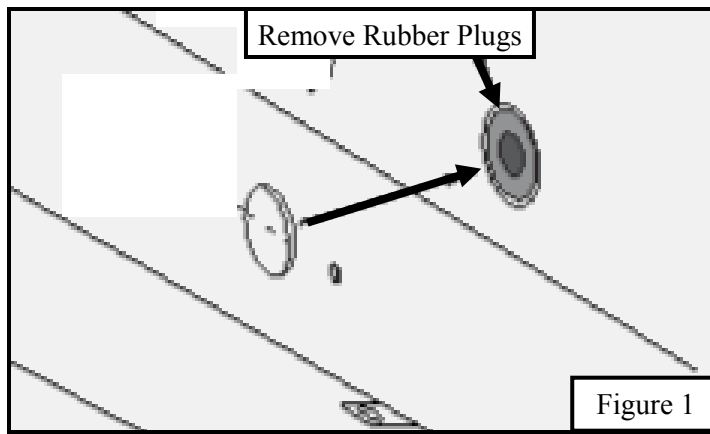
2. Starting on the driver side, remove any rubber plugs located on the rocker panel at each mounting location. See **Figure 1**.

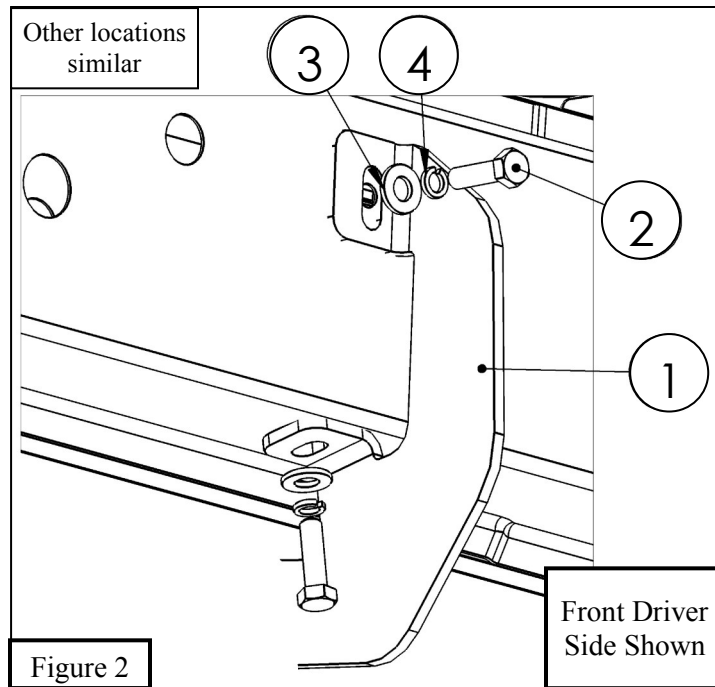
3. Locate (1) Mounting Bracket (Item 1) and loosely secure it to the rocker panel using the provided hardware: (2) M8 hex head bolt, (2) M8 flat washer, and (2) M8 lock washer. See **Figure 2**.
4. Repeat **Step 4** for the remaining bracket mounting location, see **Page 3** for bracket location.

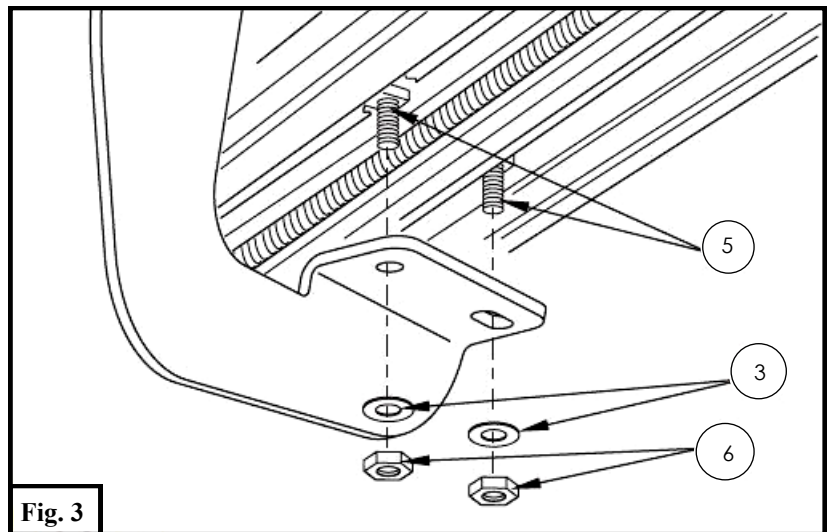
5. Lay the running boards on top of the brackets.
6. Slide the M8 square head bolts (5) through slots on the bottom of the running board (excluding the center slot, three bolts per slot).
7. Loosely install the supplied M8 flat washers (3) and M8 nylon lock nuts (6). See **Figure 3**.
8. Align and adjust the running board as needed and fully tighten all hardware. Torque all M8 fasteners to 15-18 ft-lbs.

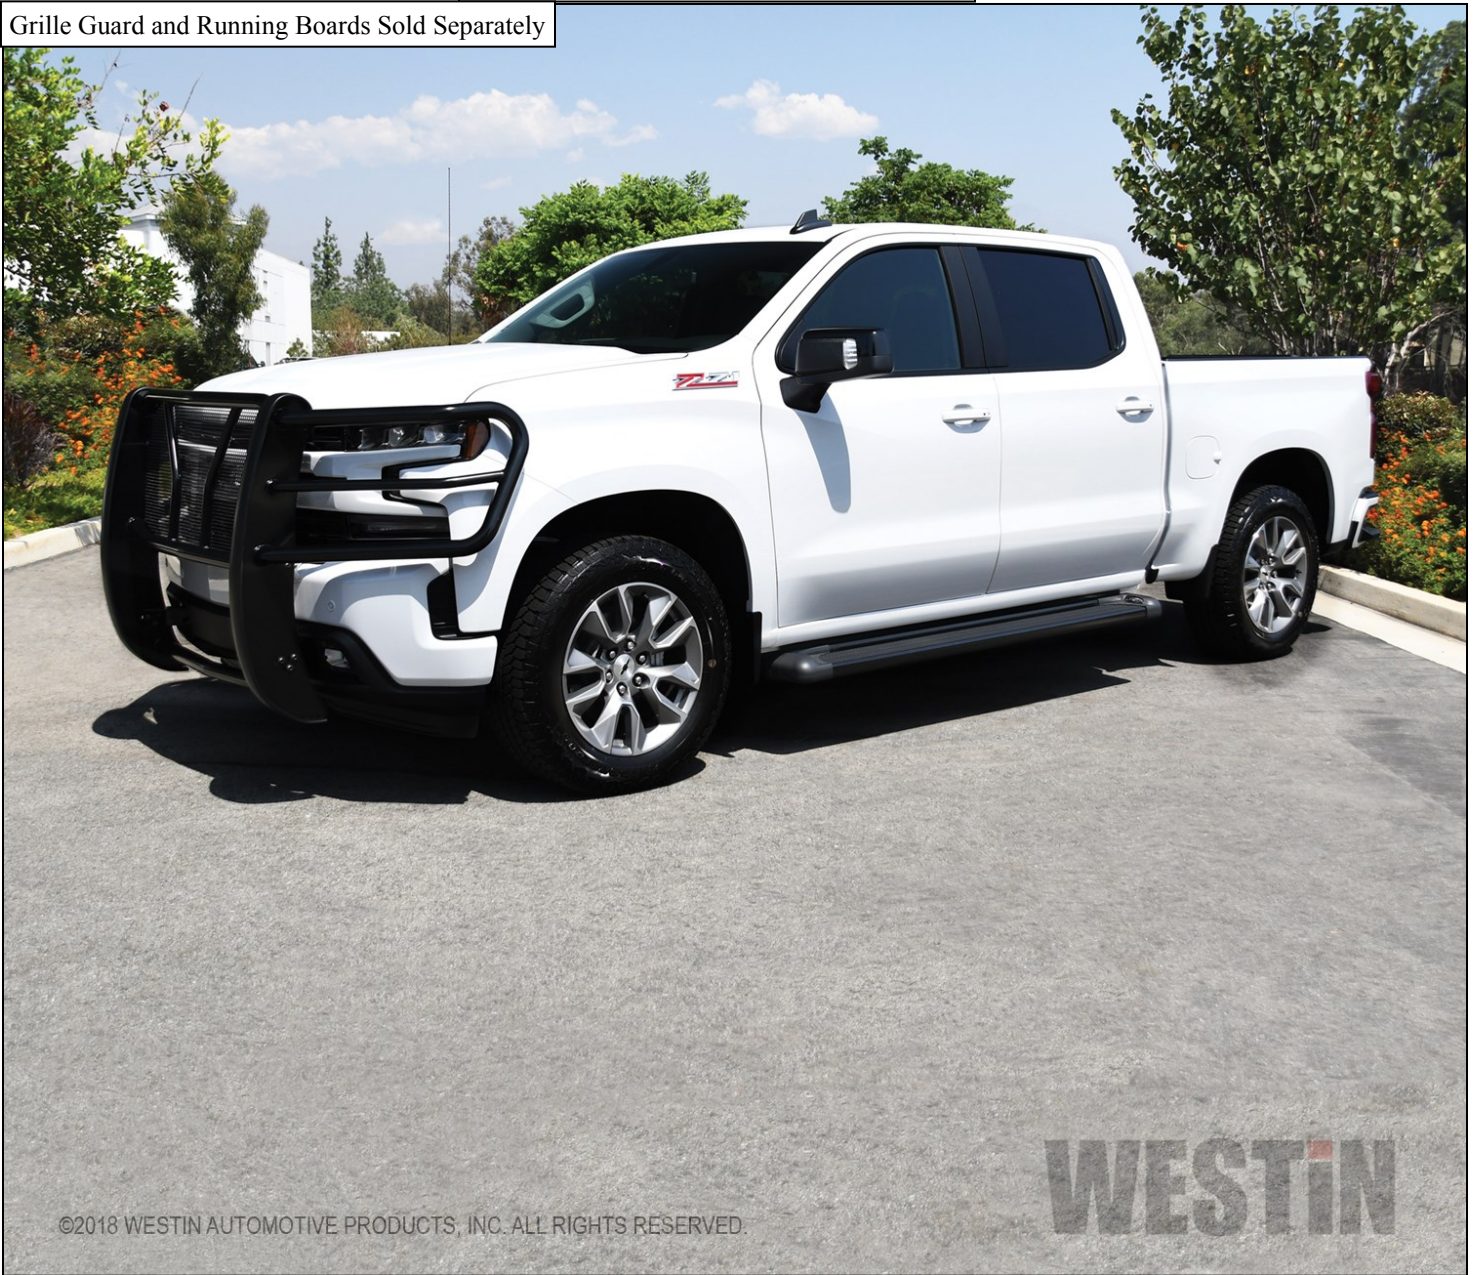
INSTALLATION COMPLETE

Grille Guard and Running Boards Sold Separately
